NASA Technical Memorandum 113128

Hot Corrosion of Single-Crystal NiAl-X Alloys

James A. Nesbitt
Lewis Research Center, Cleveland, Ohio

May 1998

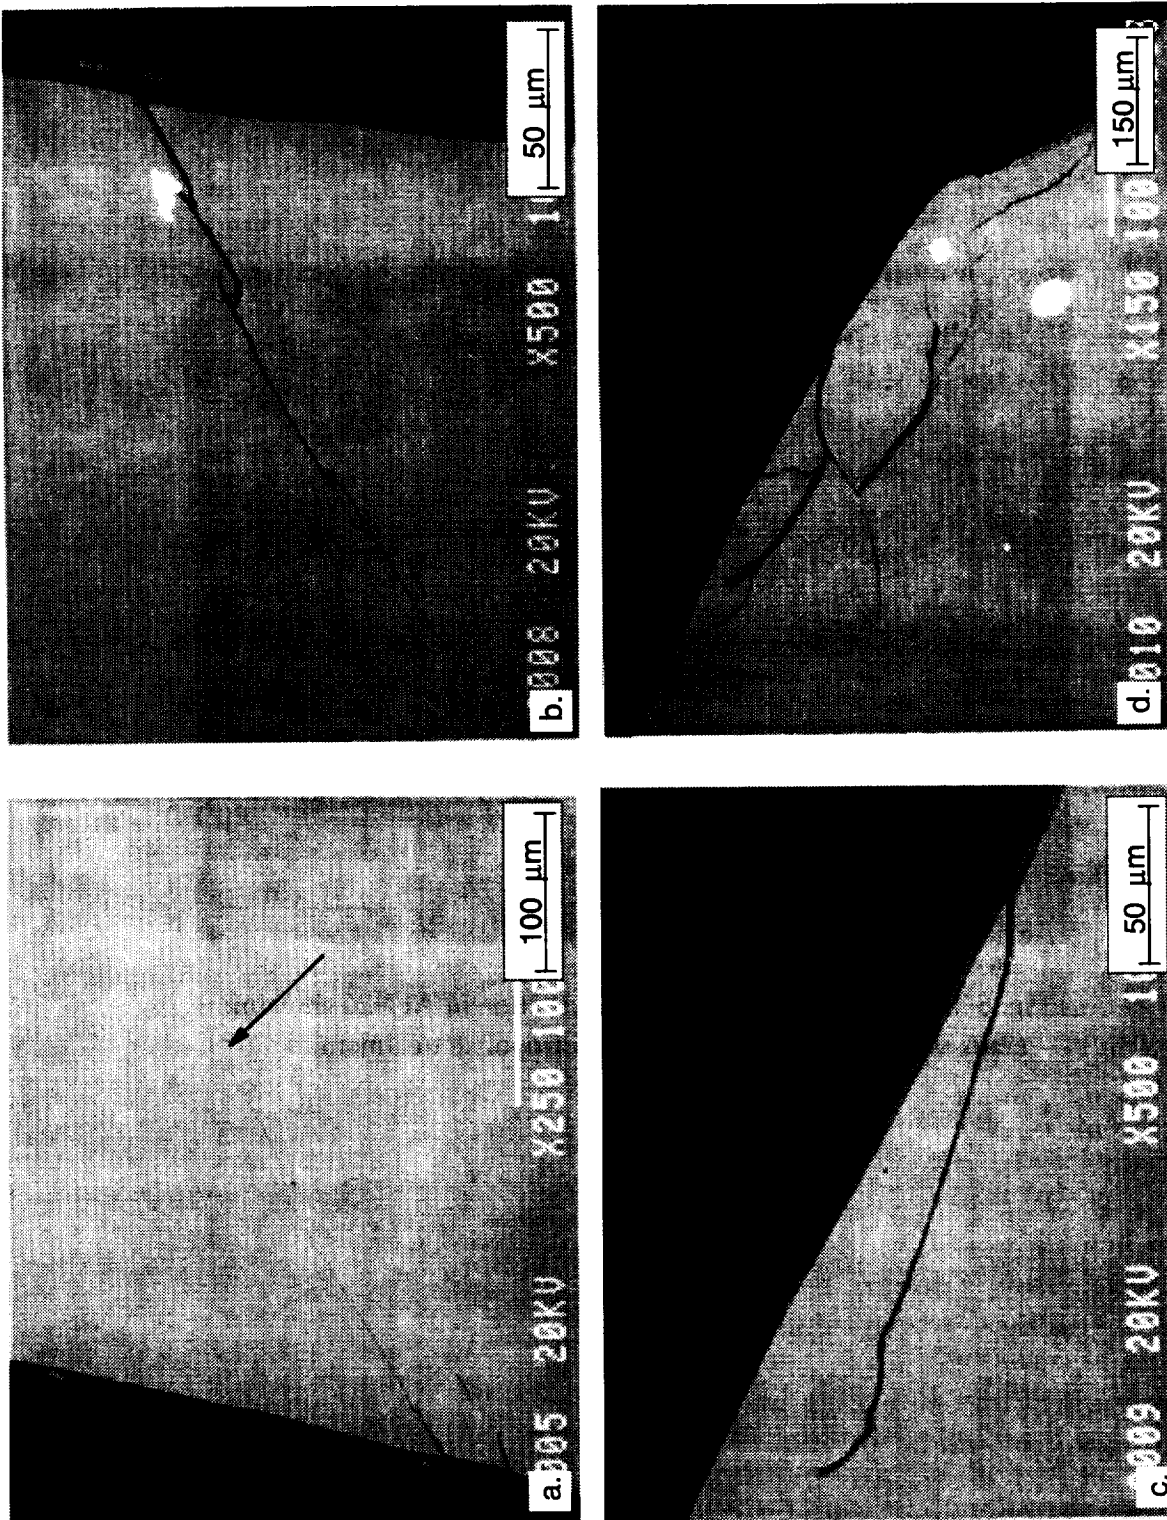
Fig. 5 SEM photos of AFN26 showing cracks from EDM cutting (a),(b) at the ID edge, and (c),(d) at the OD edge. Arrow shows depth of penetration in (a). (Bright particles in (b) and (d) are Hf-rich Heusler and/or NiHfSi particles.

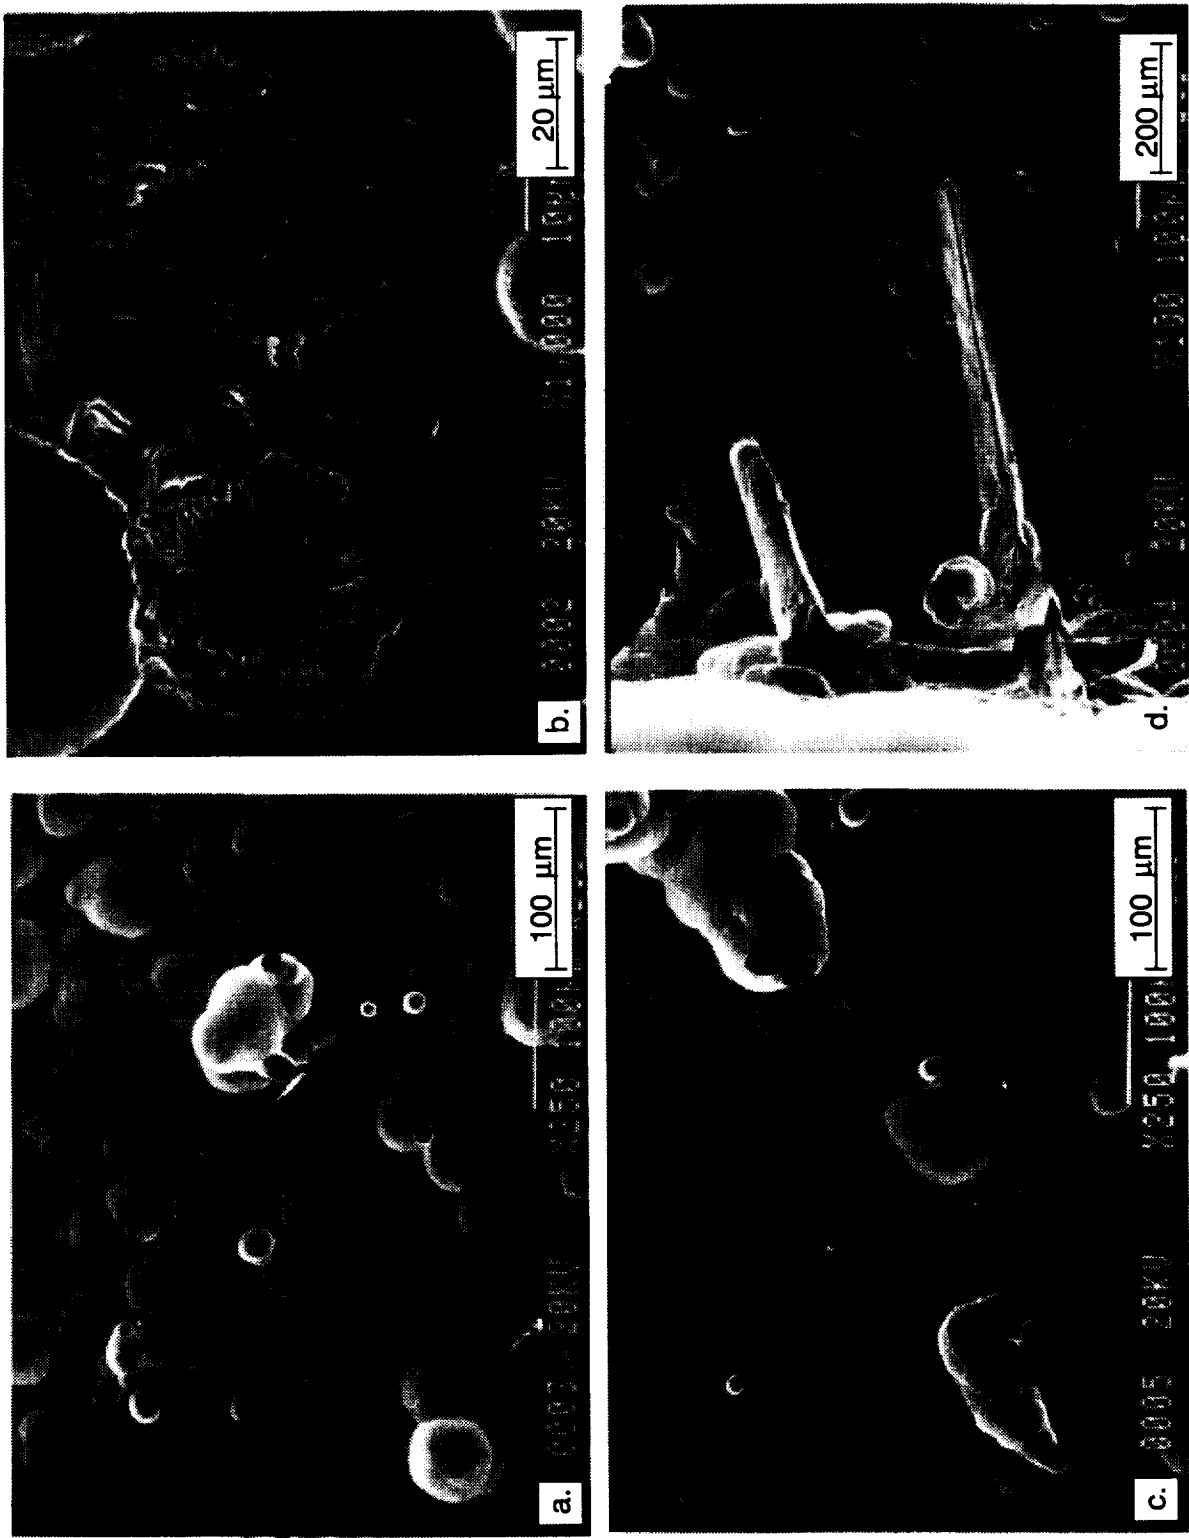
Microstructural Features. At an intermediate magnification, the surface of D218, which had only received the chemical milling treatment, appeared polycrystalline (Fig 12a). However, at higher magnifications, large, shallow, oval-shaped etch pits were apparent (Fig 12b) as well as surface-connected porosity (Fig 12c). This morphology was typical on the curved surfaces, flat ends, as well as what could be seen on the ID surface. Cracks near the edges appeared widened and crack tips blunted (Fig 12d). The chemical milling treatment also revealed small HfO_2 particles highlighting subgrain boundaries (Fig 13a,b), oxide/carbide particles at the surface (Fig 13c), as well as other unidentified microstructural features (Fig 14).

Fig. 12 SEM photos of the surface of D218 after chemical milling (a,b) general surface features, (c) porosity, and (d) blunted cracks.

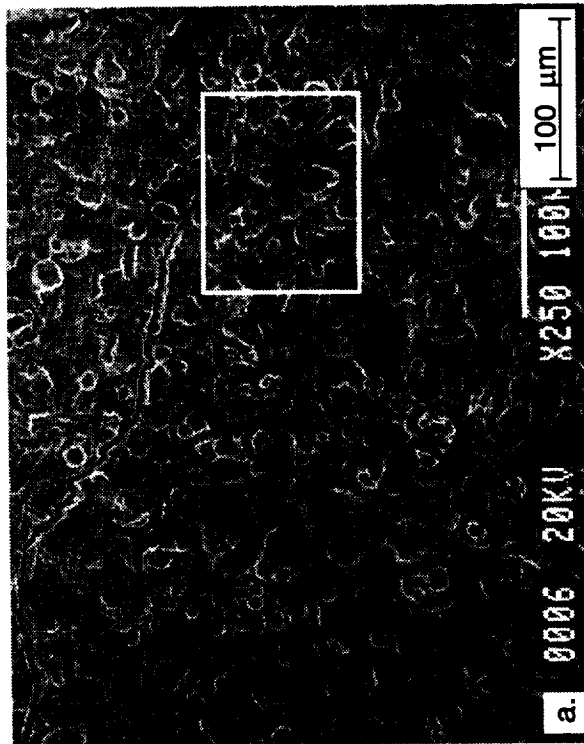
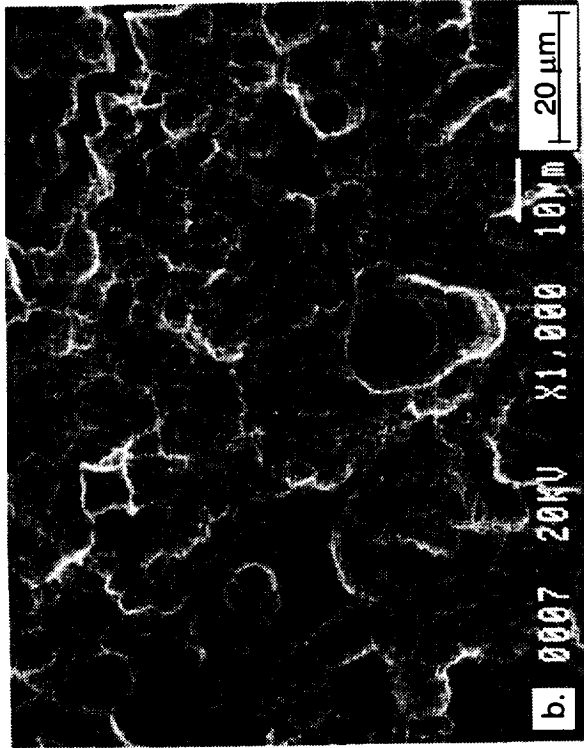
Fig. 20 SEM micrographs of D219 after chemical milling showing porosity, pits and attack at a subgrain boundary.

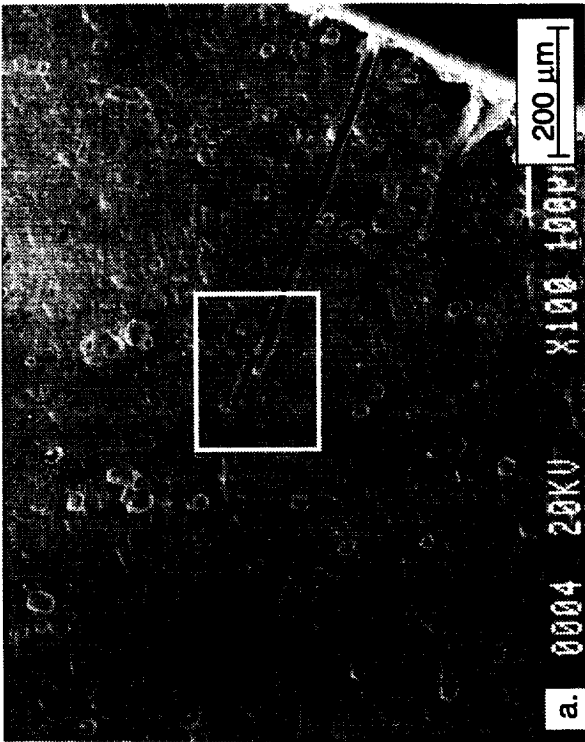
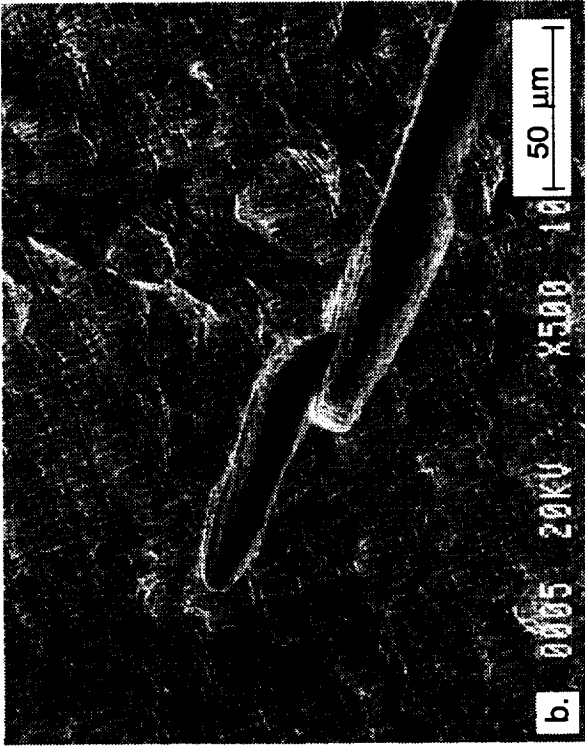
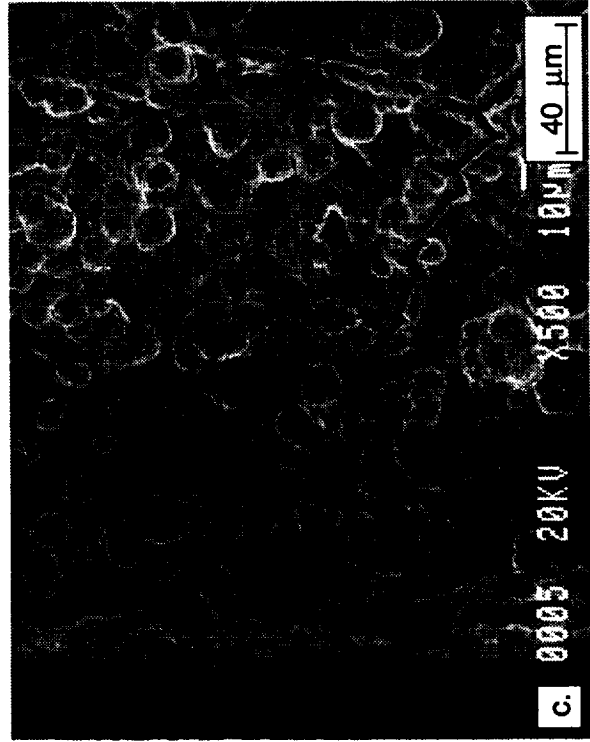
Fig. 21 SEM micrographs of cracks at the surface after chemical milling (a,b) AFN20, (c) D219.

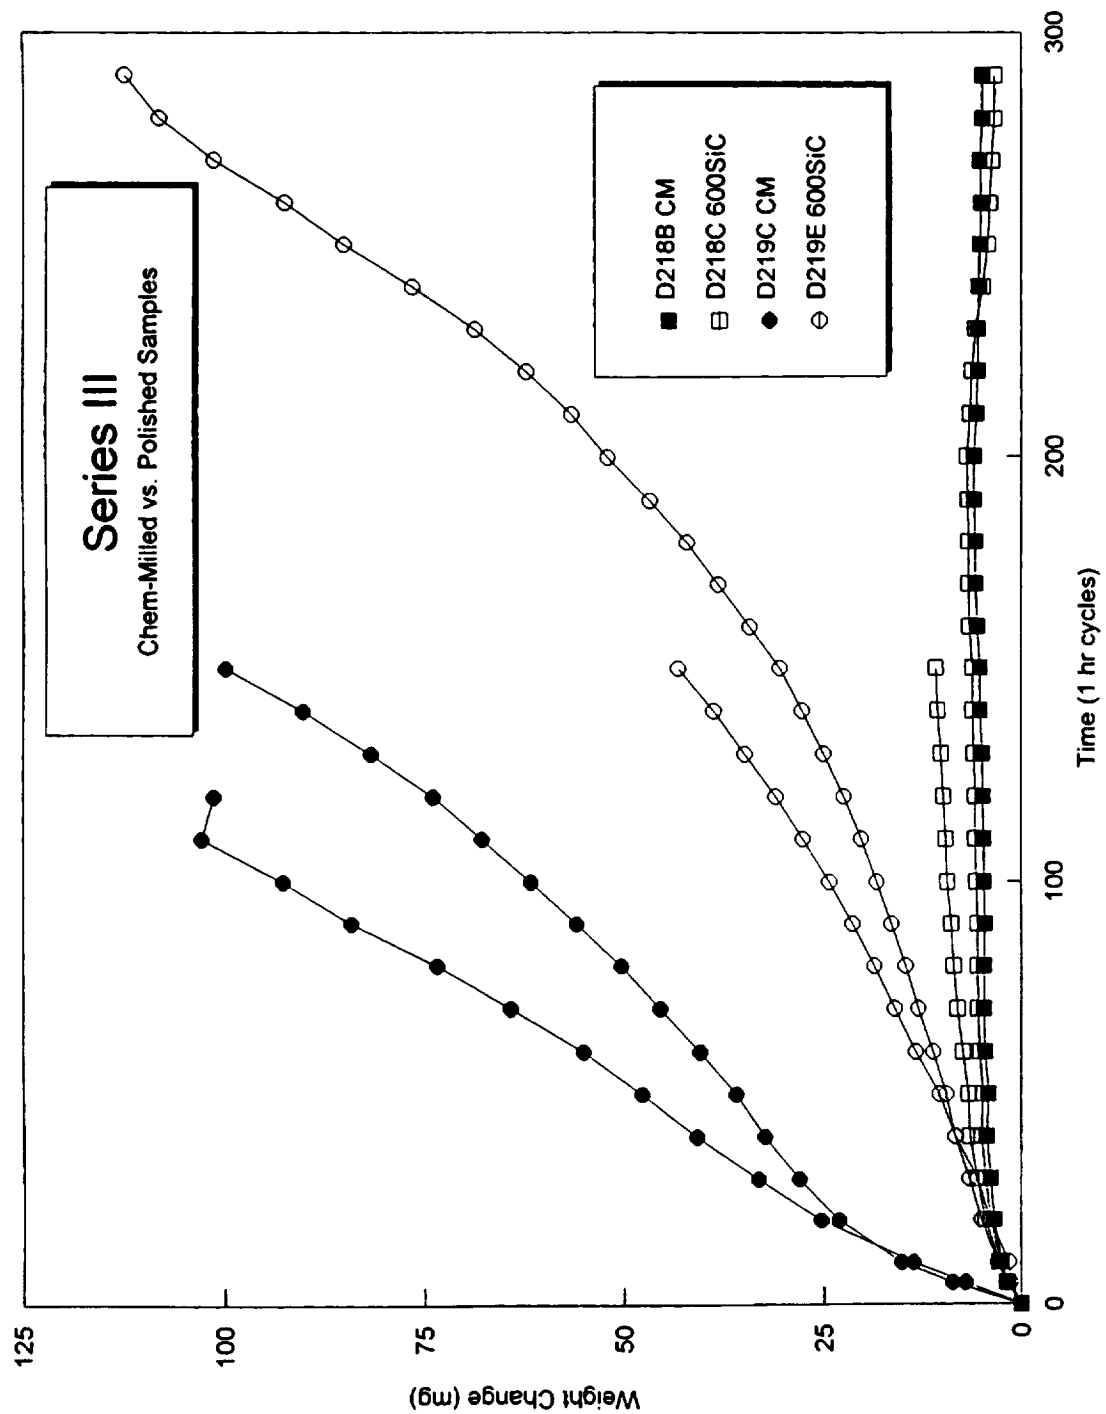
Mechanically polishing the surface of D219 through 600 grit SiC paper increased the time before the onset of rapid weight gain (Fig 38). Mechanically polishing the baseline alloy D218, which already exhibited good resistance to hot corrosion attack, had little effect on the weight change. Hence, mechanically polishing the surface appears to improve the hot corrosion behavior, at least for the alloys with poorer hot corrosion resistance.

There were significant differences in the hot corrosion response between samples which were chemically milled and those mechanically polished through 600 grit SiC paper. The lower weight gain of the mechanically polished samples (Fig 38) is reflected in the corrosion morphology after 50 hrs, as shown in Figs 71 and 72. Small distinct mounds are apparent on the surface and ends although one of the samples (D219F) exhibited a localized, scaly reaction product on one portion of the curved surface (Fig 71c). The growth of the corrosion mounds after 300 hrs on D219E is shown in Fig 73. In contrast to the mechanically polished samples, most of the surface of the chemical milled samples showed a relatively uniform and continuous attack (Figs 74, 75) although one end of D219D exhibited the distinct mound formation (Fig 74a). The uniform attack on the curved surface of the chemically milled samples shows the cast dendritic structure in relief (Fig 75c), again indicating that the growth of the hot corrosion attack is inward. Although the uniform attack gives an appearance as being less severe than the large, distinct mound formation, the depth of the attack was sufficient that after only 100 hrs, large, relatively thick corroded layers began to spall from the curved surface (Fig 76). Some of the cast dendritic structure is still apparent in the intact surface (Fig 76d).

Fig. 38 Weight change during burner rig testing for Series III, chemically milled (CM) versus mechanically polished through 600 grit SiC (600 SiC) surface finishes (D218 and D219 alloys).

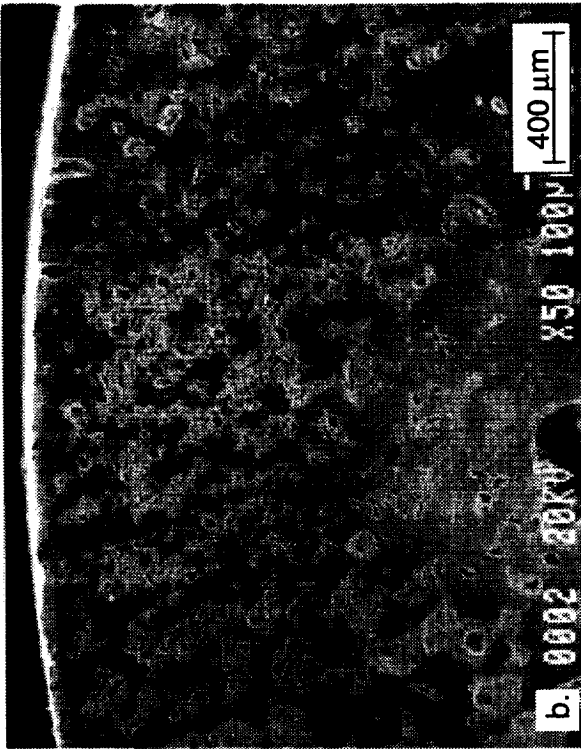
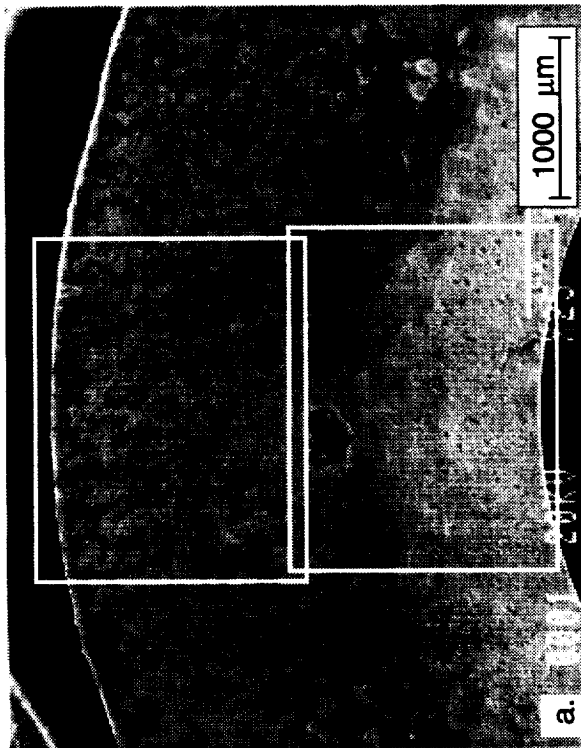
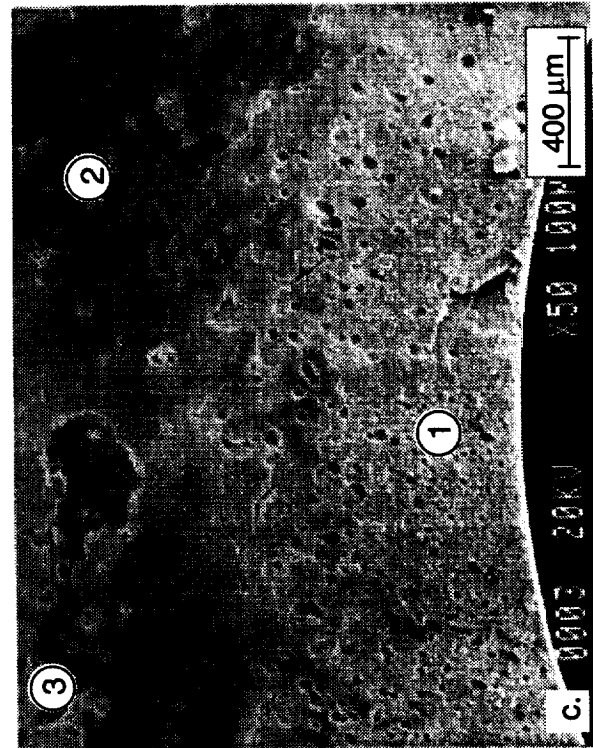
Fig. 40 SEM micrographs of (a) end of AFN19 shown in Fig. 39a, (b) and (c) are magnified views of the ID and OD edges. Arrow in (b) points to a corrosion mound.

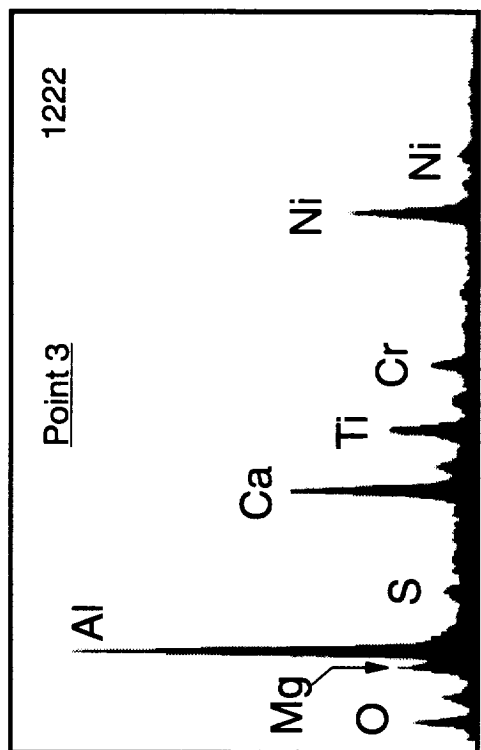
The angled view of the end of AFN19 shown in Fig 39b clearly shows that the corrosion mounds, indicated by black arrows, are not in regions of the highest porosity (Fig 42a). EDS spectra of smooth regions between the mounds again showed high Ca and

Fig. 42 SEM micrograph of (a) end of AFN19 shown in Fig. 39b (b), (c) and (d) are EDS spectra of points 1, 2 and 3 in (a). Black arrows in (a) point to corrosion mounds.

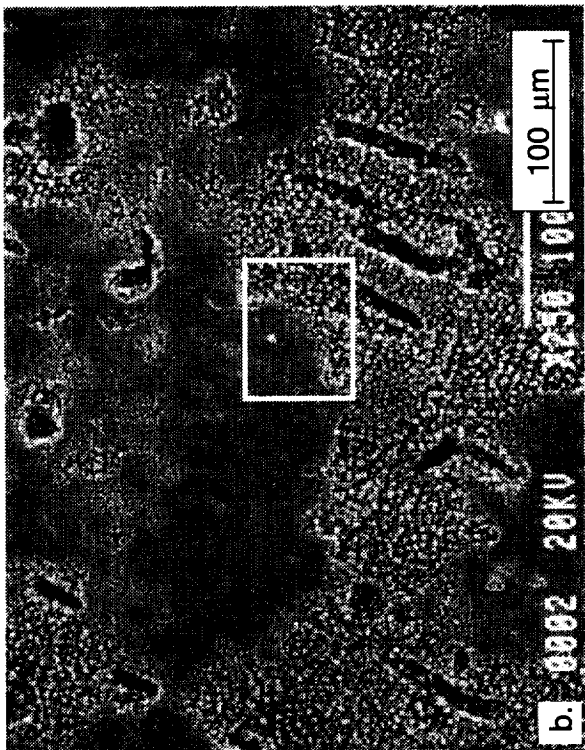
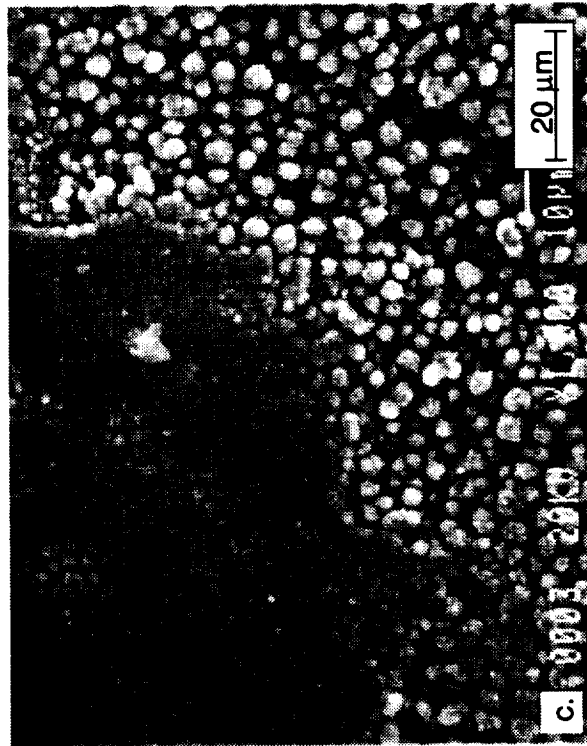
Fig. 43 SEM micrographs of end 2 of AFN19 after 300 cycles, (b) and (c) are magnified views of (a) and (b).

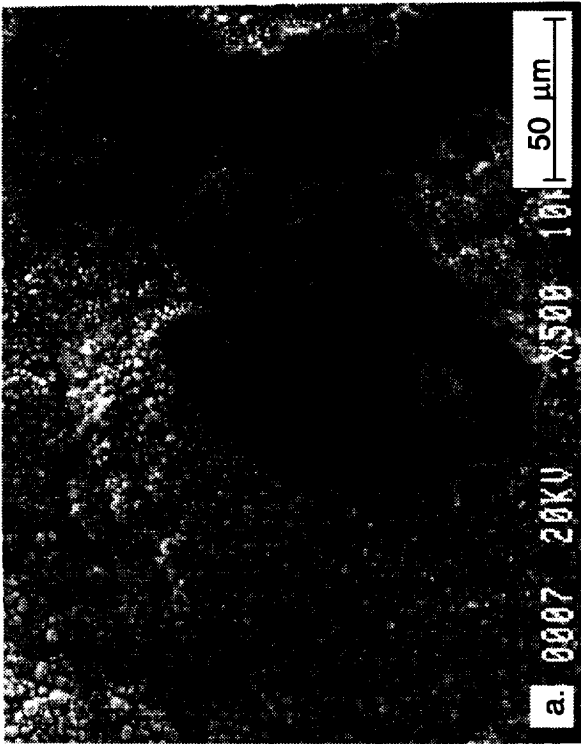
Fig. 61 SEM micrographs of the top of a corrosion mound on the rough end of AFN20 after 300 cycles, (a) SEI image, (b) BSE image, and (c) EDS spectra of point 4.

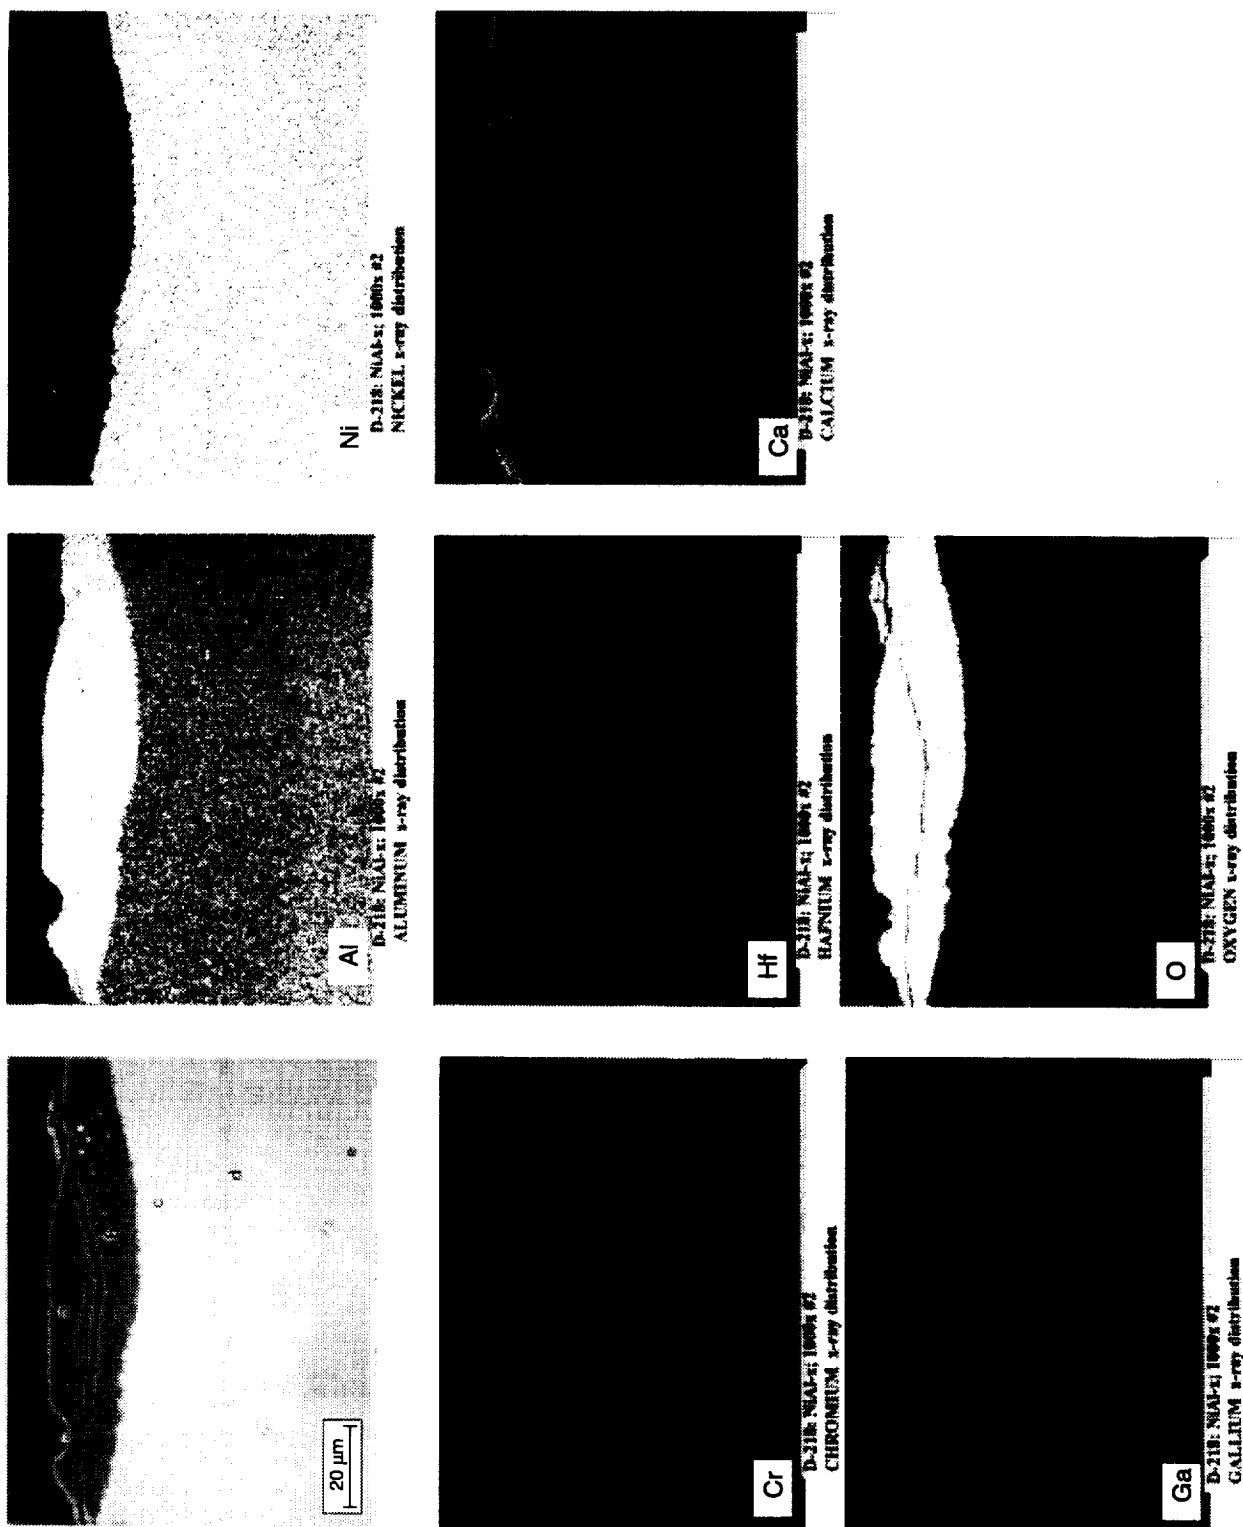
Fig. 87 X-ray maps of a broad, shallow pit in D218.

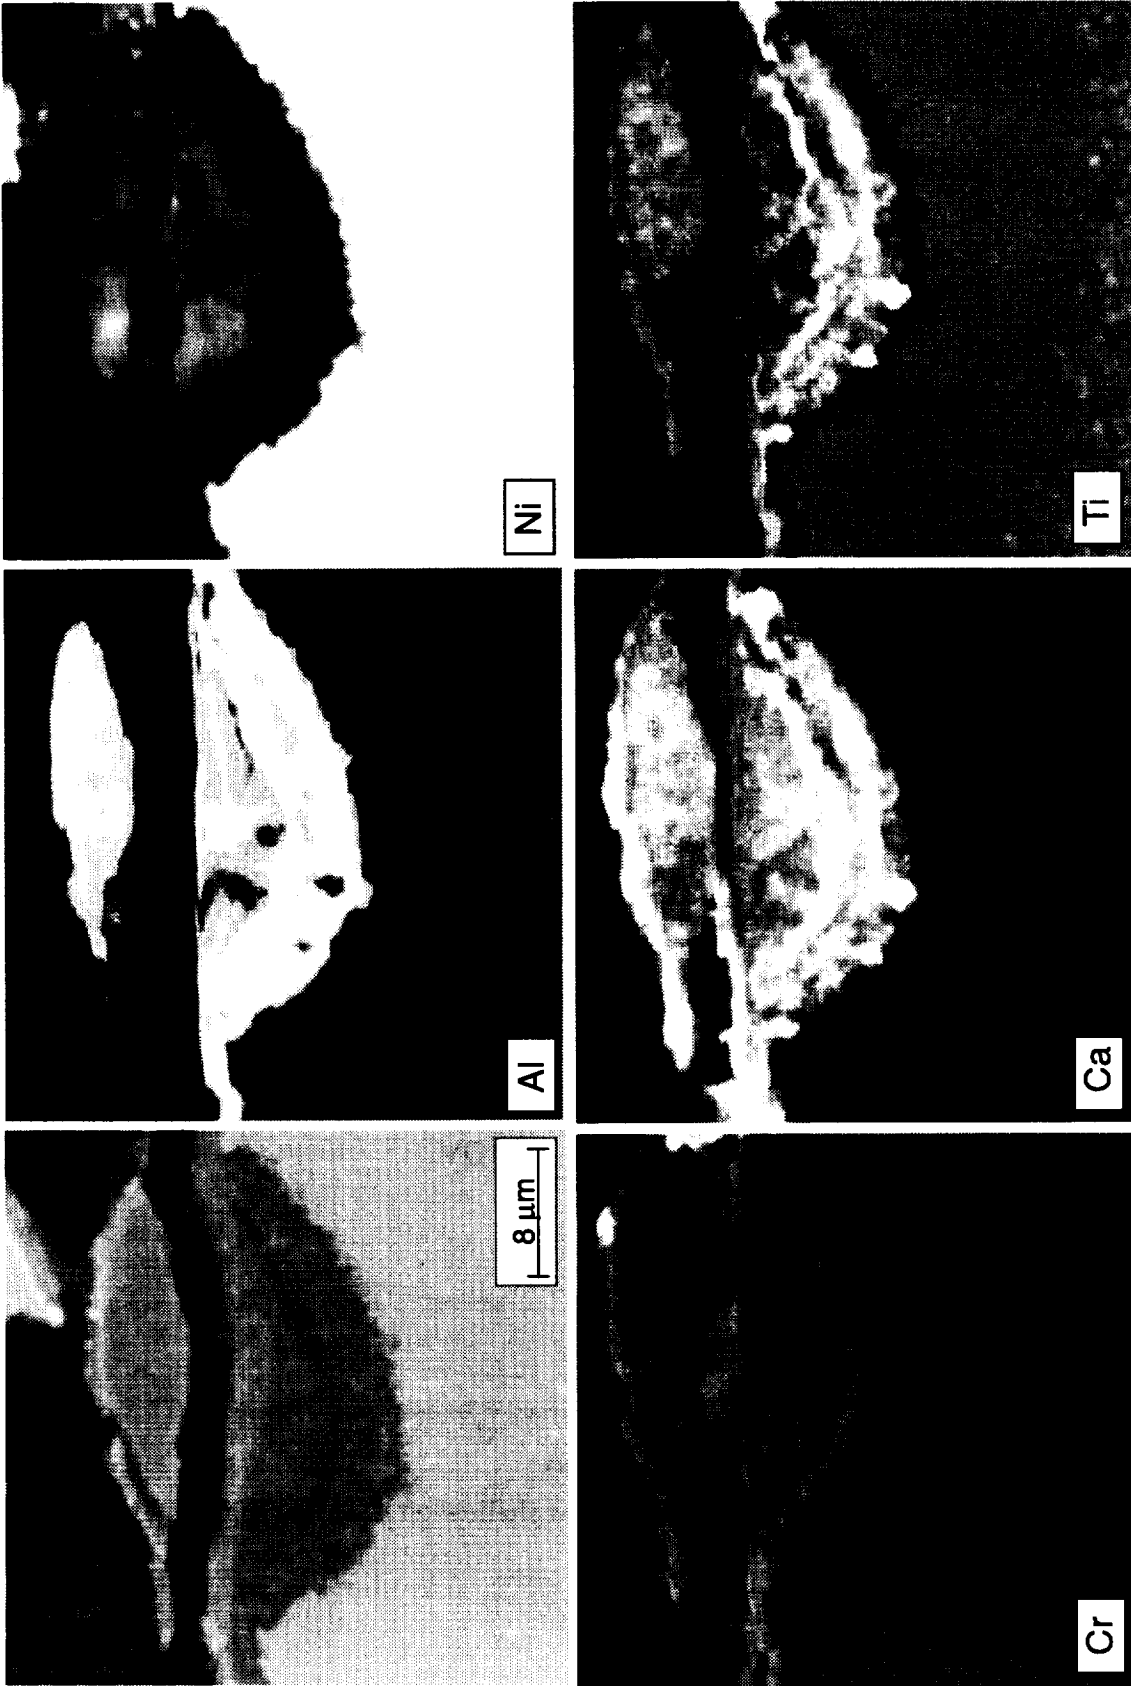
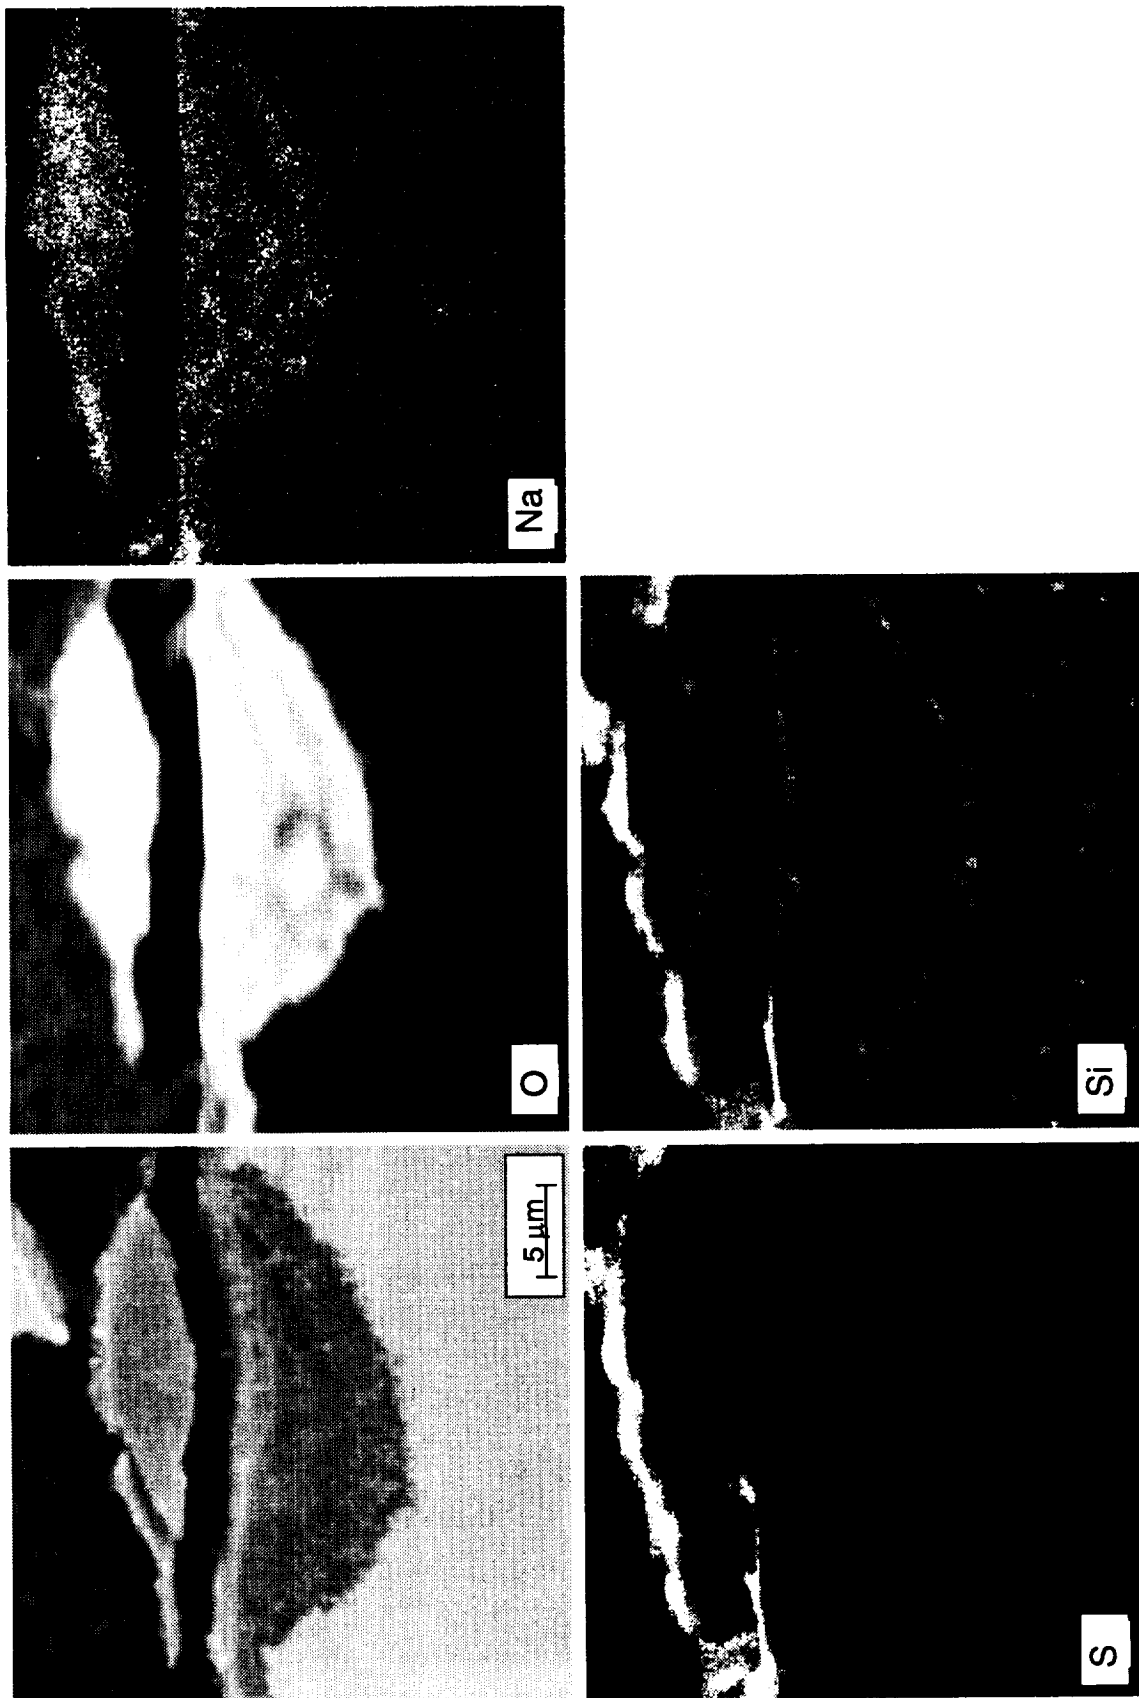
Fig. 89 X-ray map of attack initiation on AFN19 after 300 hrs.

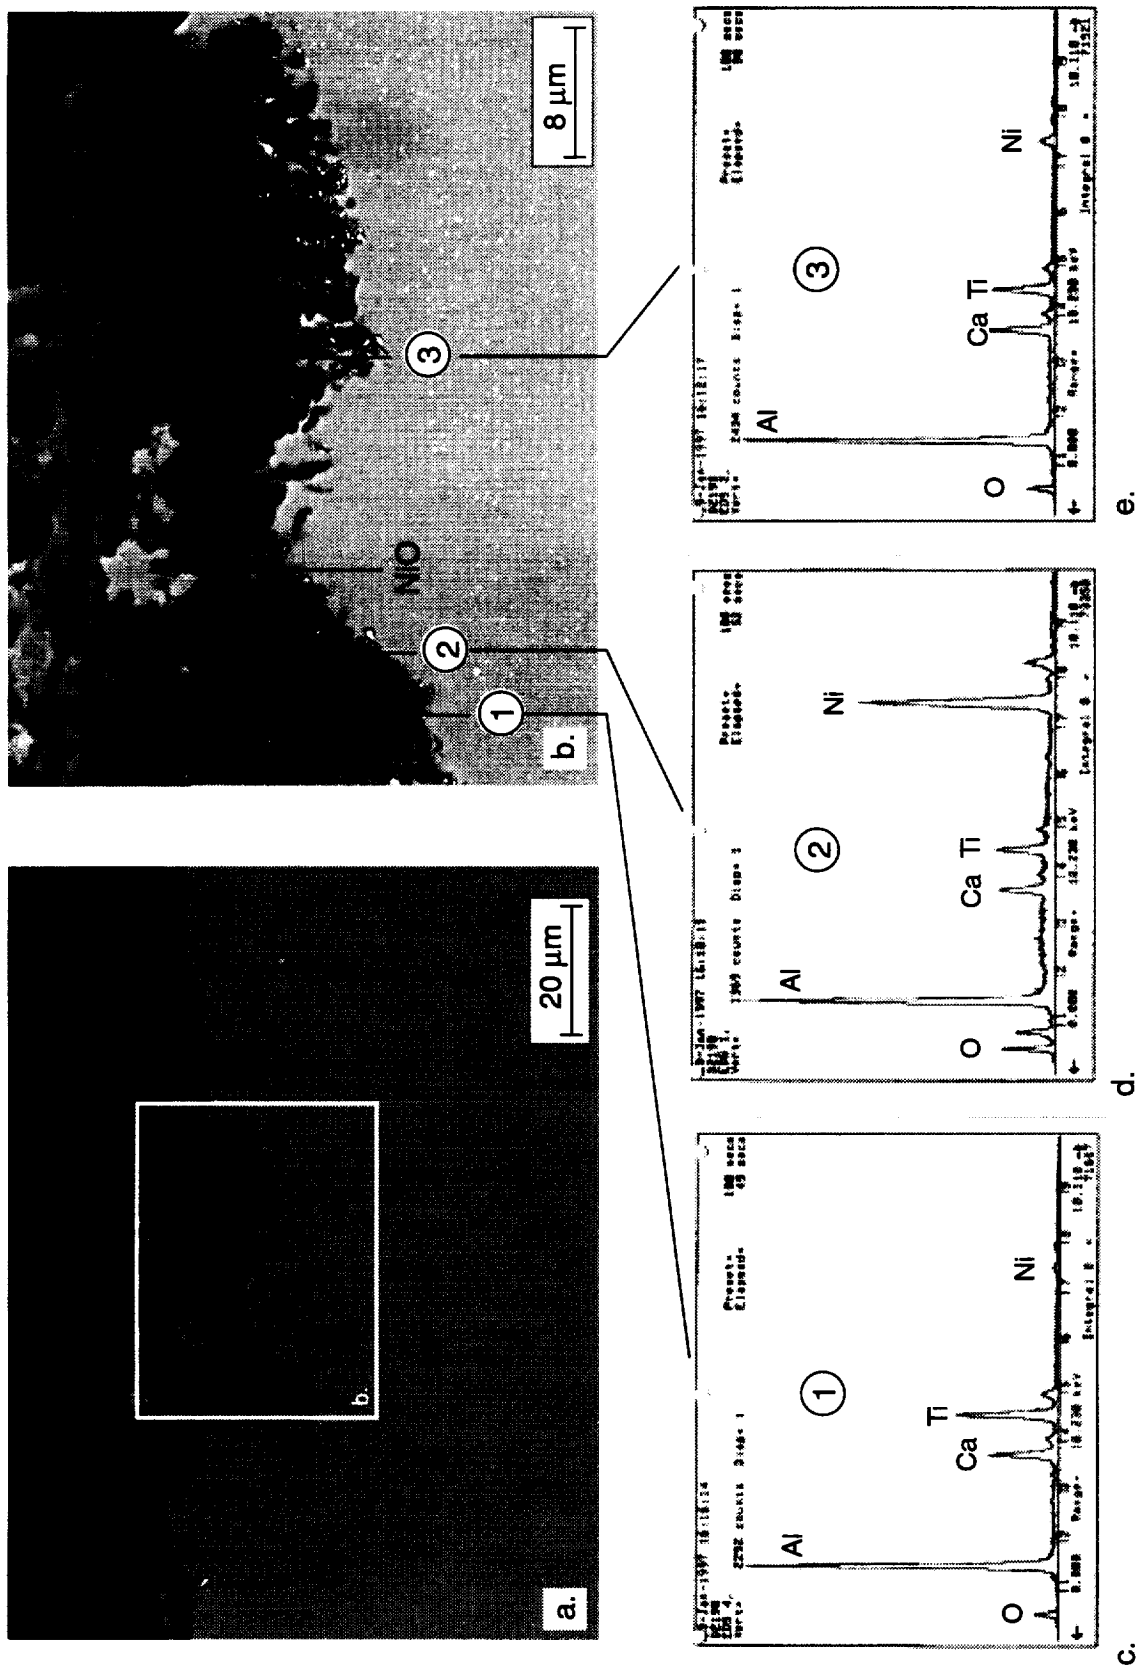
Fig. 95 Intermediate attack in D219. EDS spectra show various oxide compositions in (b).

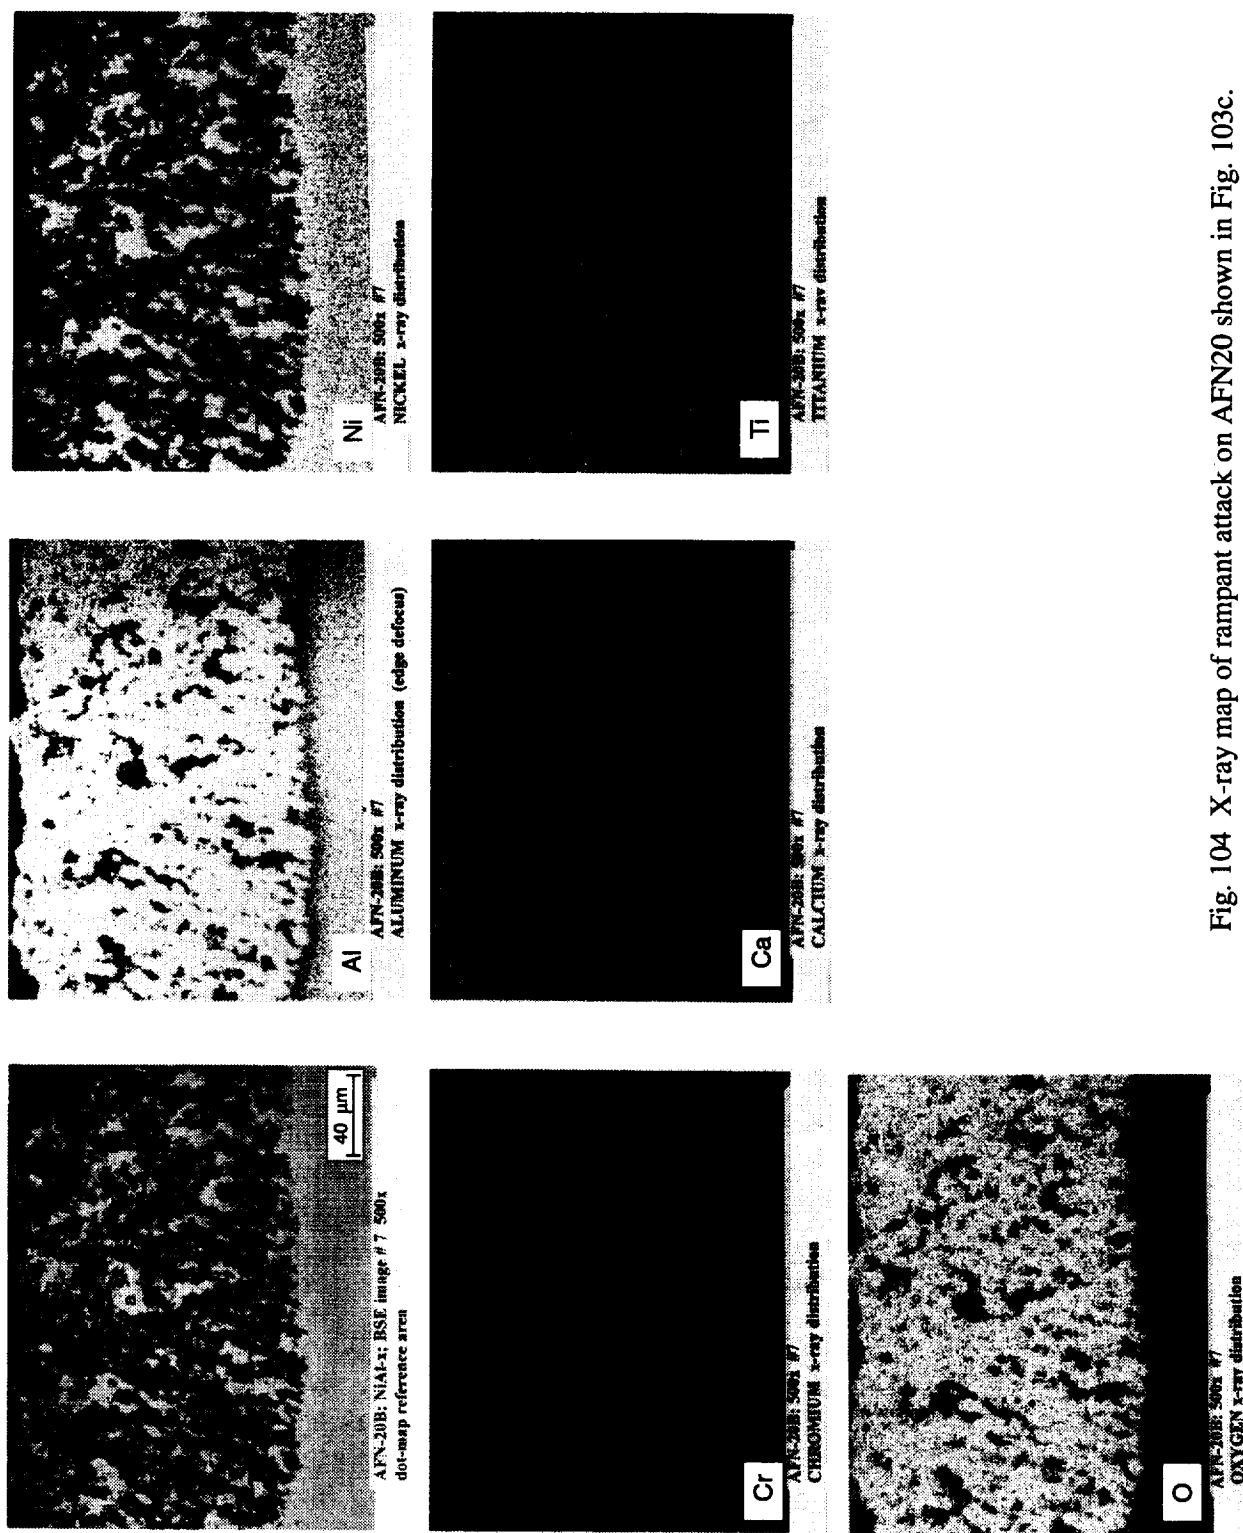
Fig. 104 X-ray map of rampant attack on AFN20 shown in Fig. 103c.

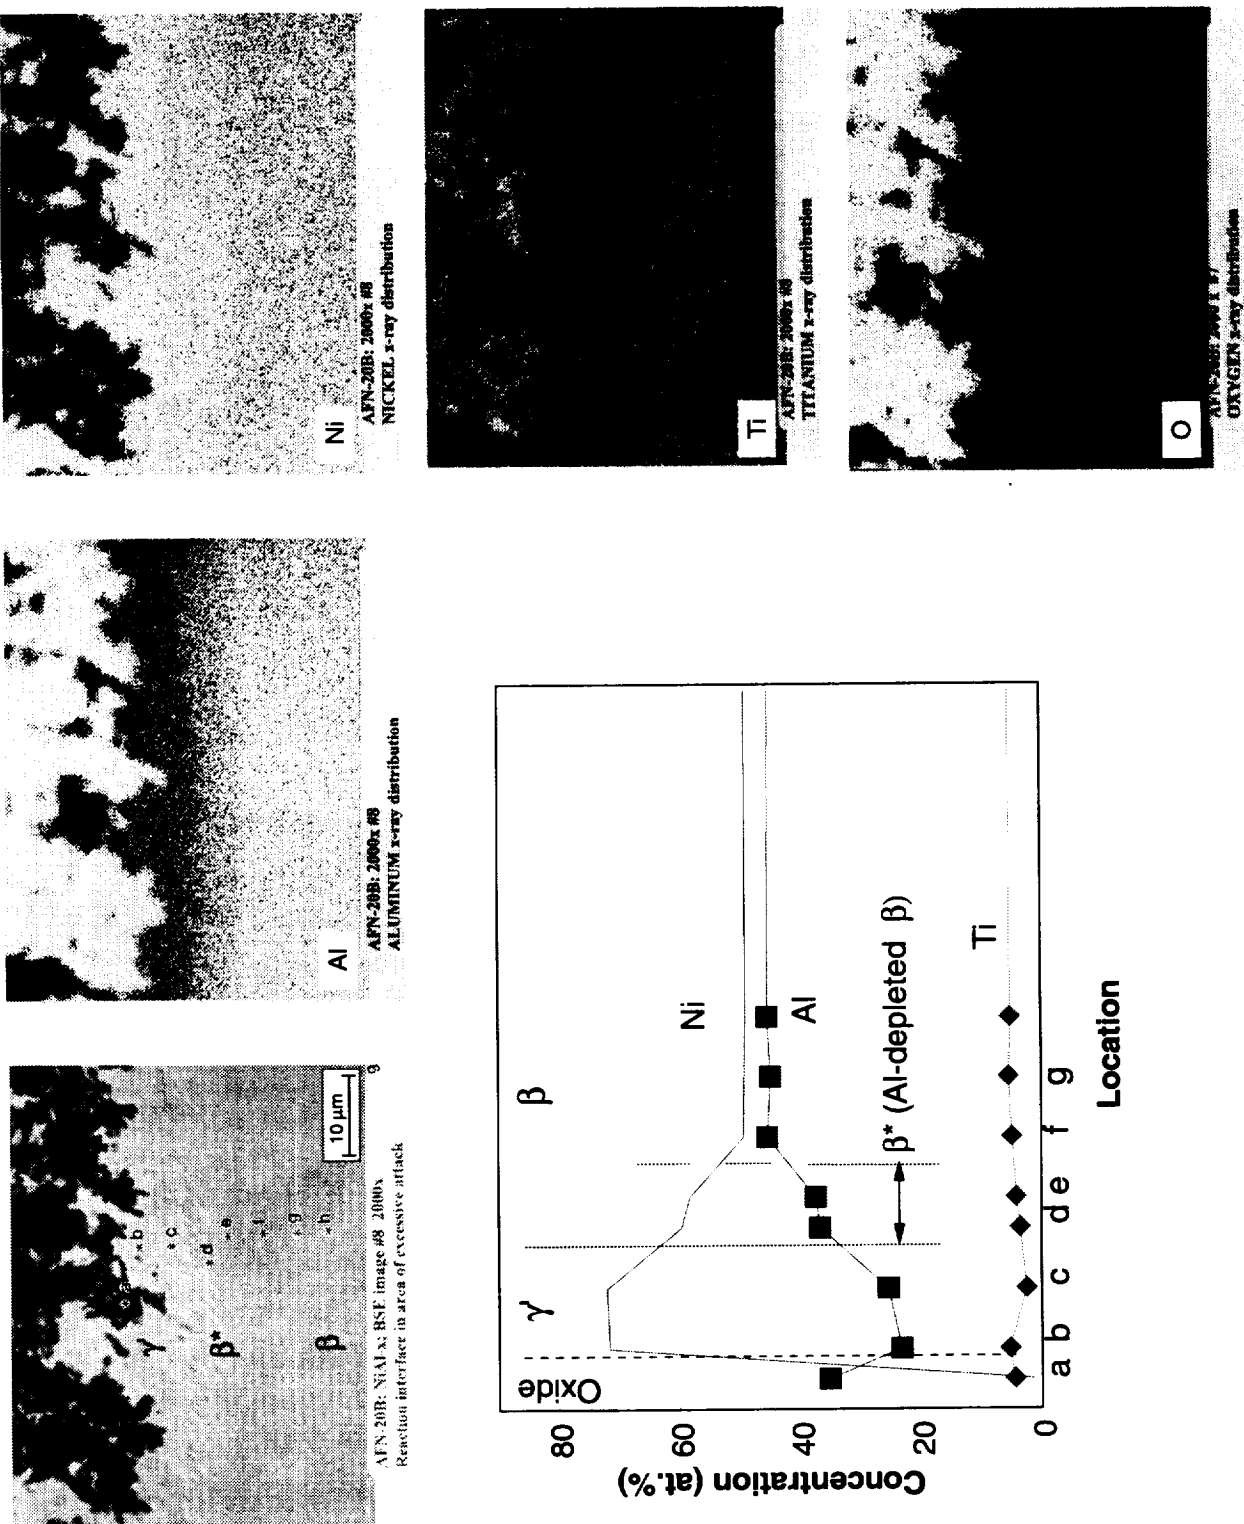
Fig. 105 X-ray map and concentration profile of the inner region of rampant attack shown in Fig. 104a (AFN20).
